**NORTH DAKOTA  
DEPARTMENT OF TRANSPORTATION**

Experimental Study ND 2002-01

**Base Reinforcement Using Geogrid**

**Construction Report**

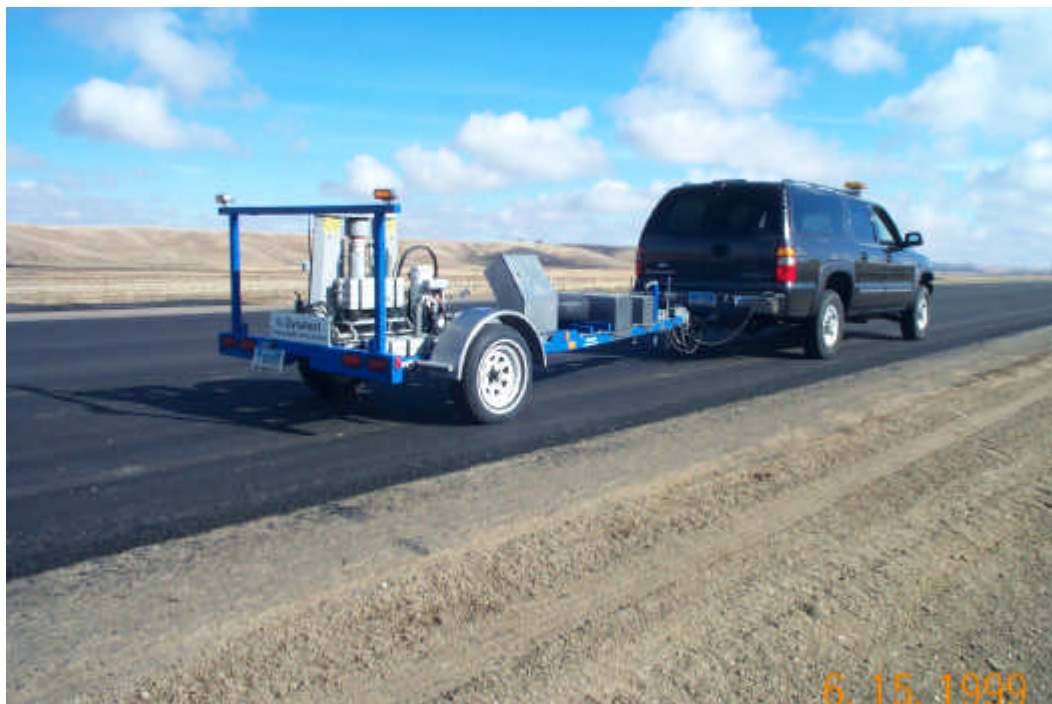
**Photo 12 – The FWD operation.**

The Falling Weight Deflectometer (FWD) is one tool that is used to help evaluate roadway systems. It drops a pre-selected load onto the pavement surface. The resulting deflection of the roadway system is measured and stored. The modulus of each layer is calculated from the data using the Elmod 5 program. The FWD is shown in photo 12.
